**Flood Control Project Maintenance
Levee Inspections**

Fall 2018 Levee Maintenance Deficiency Summary Report

Sacramento River Basin

**Flood Control Project Maintenance
Levee Inspections****LMA District Cover Sheet****Fall 2018 Levee Inspection Results****Tehama County Flood Control and Water Conservation District**

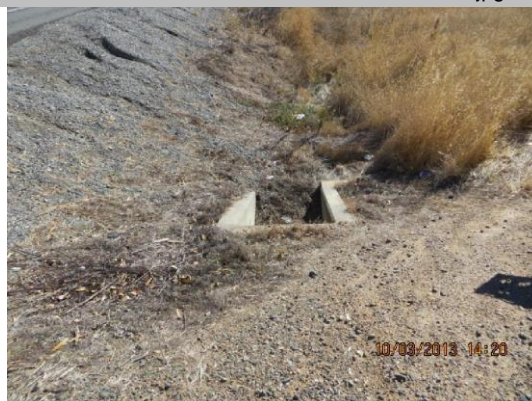
Photo 1 of 3 : UCIP_FA_2018_21788_37050.jpg

LM Start	1.07	Rating **	A/W	Issue No.	924
LM End	1.07	Issue Type +	Ma	Location *	
Category	Supplemental			GPS Latitude/Longitude	
				Start	End
Item	DWR UCIP LMA Responsibility			40.052400 °	40.052400 °
				-122.170279 °	-122.170279 °
DWR ID	20790				
Comment Code					
Inspector Comment					
FS_ID:21788					
DS_ID:20790					
EP_NO: N/A					
Repair Type: No Action Needed					
Crossing Status: Found					
UCIP Comments:					
FIELD_STRUCT_DESC: 24-inch corrugated metal drainage pipe through the levee, 5 feet below the crown. Flap gate and concrete U-shaped headwall on the waterside (WS) end. Concrete U-shaped headwall on the landside (LS) end. [Additional Reference(s): DWR Levee Log, 1992. USACE Sacramento O&M Manual 510, April 1963, (HLM 1.10) Drawing No. 50-4-3622].					
FS Date: 10/3/2013

Concrete U-shaped headwall on WS toe.

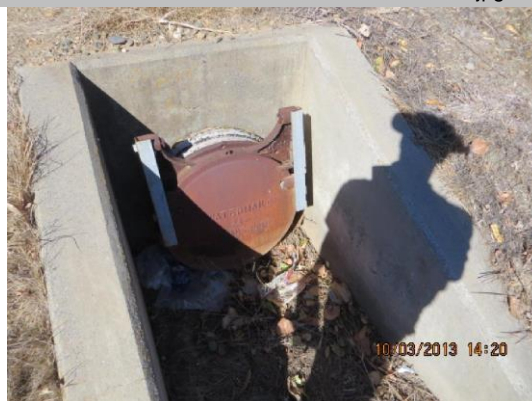
Photo 2 of 3 : UCIP_FA_2018_21788_37053.jpg

Concrete U-shaped headwall and flapgate on WS toe.

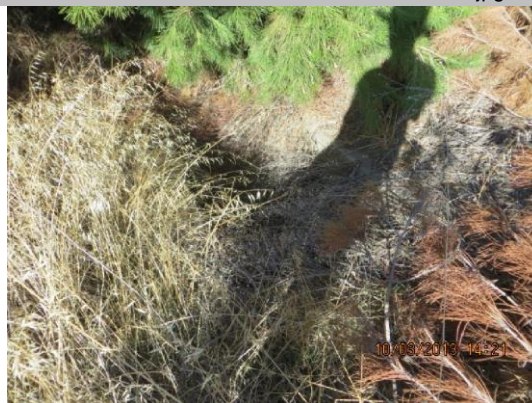
Photo 3 of 3 : UCIP_FA_2018_21788_37052.jpg

Concrete U-shaped headwall on LS toe.

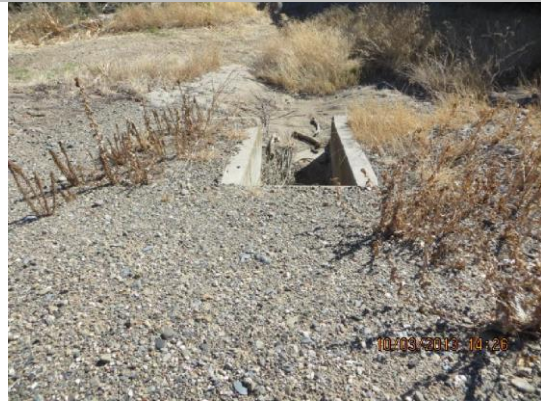
Photo 1 of 2 : UCIP_FA_2018_21786_37048.jpg

LM Start	1.11	Rating **	A/W	Issue No.	925
LM End	1.11	Issue Type +	Ma	Location *	
Category	Supplemental			GPS Latitude/Longitude	
				Start	End
Item	DWR UCIP LMA Responsibility			40.051958 °	40.051958 °
				-122.170031 °	-122.170031 °
DWR ID	20773				
Comment Code					
Inspector Comment					
FS_ID:21786					
DS_ID:20773					
EP_NO: N/A					
Repair Type: No Action Needed					
Crossing Status: Found					
UCIP Comments:					
FIELD_STRUCT_DESC: 24-inch corrugated metal drainage pipe through the levee, 5.1 feet below the crown. Flap gate and concrete U-shaped headwall on the waterside (WS) end. Concrete U-shaped headwall on the landside (LS) end. [Additional Reference(s): DWR Levee Log, 1992. USACE Sacramento O&M Manual 510, April 1963, (HLM 1.12) Drawing No. 50-4-3622].					
FS Date: 10/3/2013

Concrete U-shaped headwall and flapgate on WS slope.

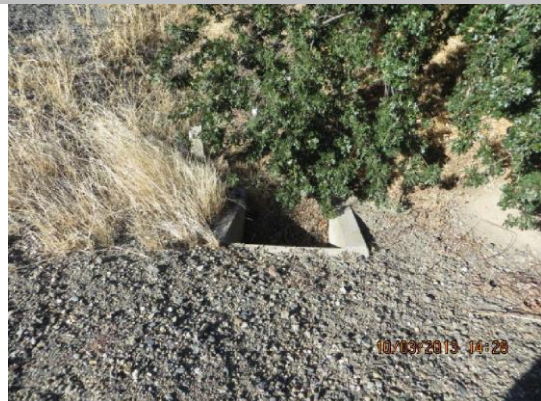
Photo 2 of 2 : UCIP_FA_2018_21786_37047.jpg

Concrete U-shaped headwall on LS toe.

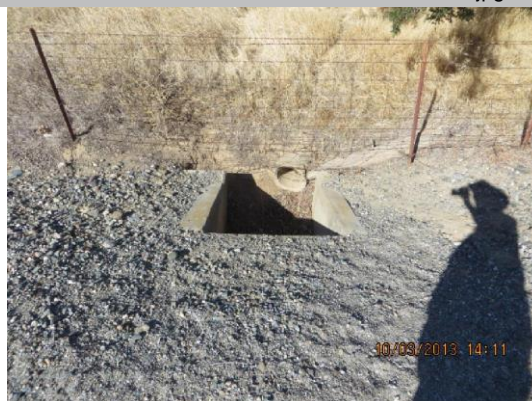
Photo 1 of 3 : UCIP_FA_2018_21778_37037.jpg

LM Start	1.30	Rating **	A/W	Issue No.	926
LM End	1.30	Issue Type +	Ma	Location *	
Category	Supplemental			GPS Latitude/Longitude	
				Start	End
Item	DWR UCIP LMA Responsibility			40.051563 °	40.051563 °
				-122.166630 °	-122.166630 °
DWR ID	20782				
Comment Code					
Inspector Comment					
FS_ID:21778 DS_ID:20782 EP_NO: N/A Repair Type: No Action Needed Crossing Status: Found UCIP Comments: FIELD_STRUCT_DESC: 24-inch corrugated metal drainage pipe through the levee, 4.5 feet below the crown. Flap gate and concrete U-shaped headwall on the waterside (WS) end. Concrete U-shaped headwall on the landside (LS) end. [Additional Reference(s): DWR Levee Log, 1992. USACE Sacramento O&M Manual 510, April 1963, (HLM 1.30) Drawing No. 50-4-3622]. FS Date: 10/3/2013

Concrete U-shaped headwall on LS toe.

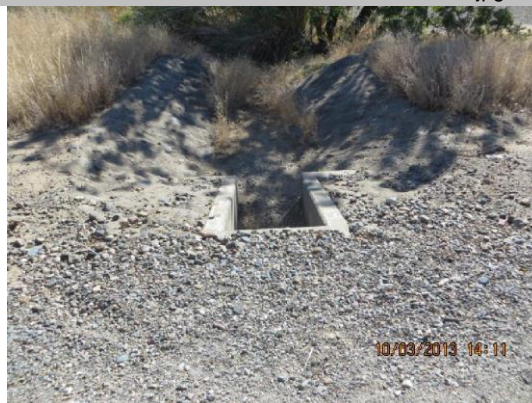
Photo 2 of 3 : UCIP_FA_2018_21778_37036.jpg

Concrete U-shaped headwall on WS toe.

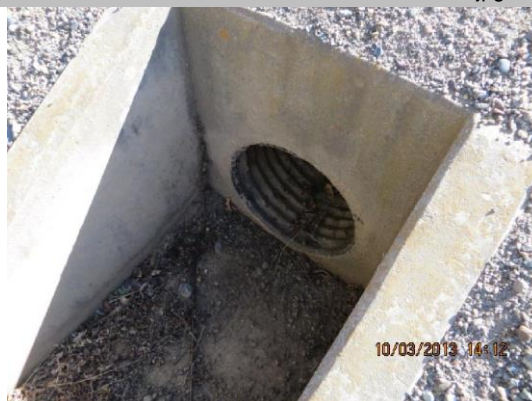
Photo 3 of 3 : UCIP_FA_2018_21778_37035.jpg

Concrete U-shaped headwall on LS toe.

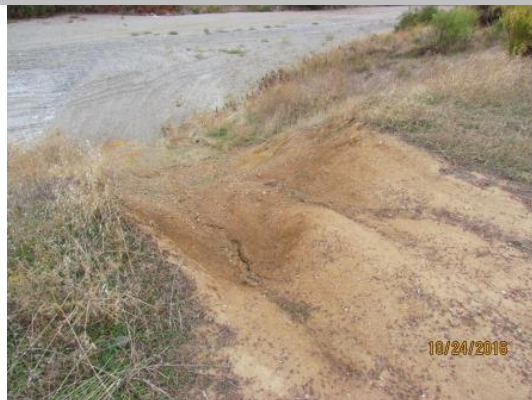
Photo 1 of 1 : FA_2018_NA0019_81_29_20180905_00016.jpg

LM Start	1.44	Rating **	M	Issue No.	29
LM End	1.44	Issue Type +	Ma	Location *	WS
Category	Earthen Levee			GPS Latitude/Longitude	
				Start	End
Item	Slope Stability			40.051785 °	40.051785 °
				-122.164075 °	-122.164075 °
DWR ID	DWR_NA0019_04_f_2016_29				
Comment Code					
S3 : Repair the levee slope damaged by vehicle traffic and prevent access where possible.					
Inspector Comment

View of the slope instability caused by vehicles along the waterside slope.

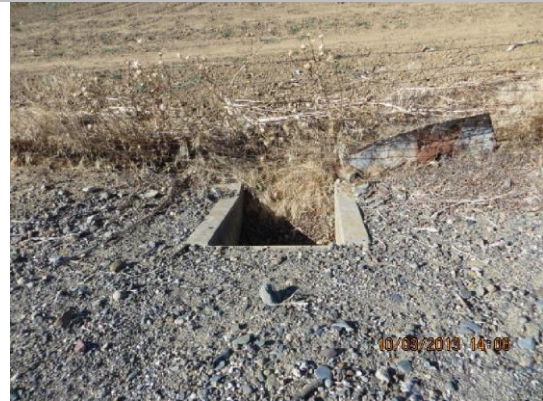
Photo 1 of 3 : UCIP_FA_2018_21776_37029.jpg

LM Start	1.56	Rating **	A/W	Issue No.	927
LM End	1.56	Issue Type +	Ma	Location *	
Category	Supplemental			GPS Latitude/Longitude	
				Start	End
Item	DWR UCIP LMA Responsibility			40.052495 °	40.052495 °
				-122.161921 °	-122.161921 °
DWR ID	20783				
Comment Code					
Inspector Comment					
FS_ID:21776 DS_ID:20783 EP_NO: N/A Repair Type: No Action Needed Crossing Status: Found UCIP Comments: FIELD_STRUCT_DESC: 24-inch corrugated metal drainage pipe through the levee, 5.8 feet below the crown. Flap gate and concrete U-shaped headwall on the waterside (WS) end. Concrete U-shaped headwall on the landside (LS) end. [Additional Reference(s): DWR Levee Log, 1992. USACE Sacramento O&M Manual 510, April 1963, (HLM 1.57) Drawing No. 50-4-3622]. FS Date: 10/3/2013

Concrete U-shaped headwall on LS toe.

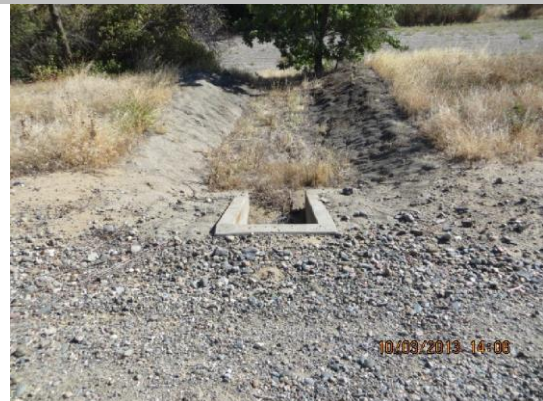
Photo 2 of 3 : UCIP_FA_2018_21776_37028.jpg

Concrete U-shaped headwall on WS toe.

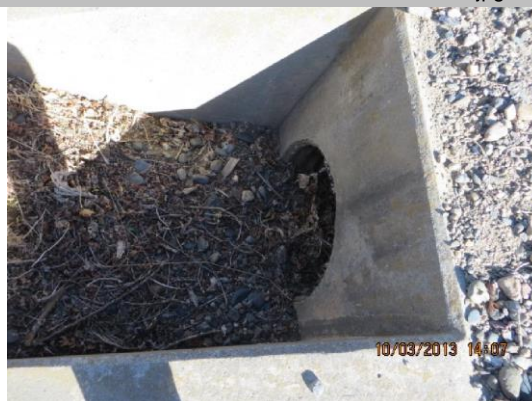
Photo 3 of 3 : UCIP_FA_2018_21776_37027.jpg

Concrete U-shaped headwall on LS toe.

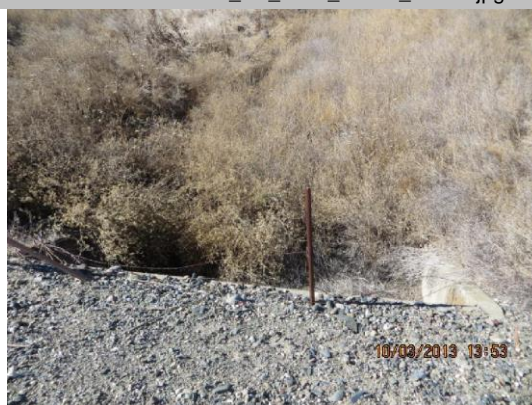
Photo 1 of 3 : UCIP_FA_2018_21769_37004.jpg

LM Start	1.69	Rating **	A/W	Issue No.	928
LM End	1.69	Issue Type +	Ma	Location *	
Category	Supplemental			GPS Latitude/Longitude	
				Start	End
Item	DWR UCIP LMA Responsibility			40.053590 °	40.053590 °
				-122.159982 °	-122.159982 °
DWR ID	20786				
Comment Code					
Inspector Comment					
FS_ID:21769					
DS_ID:20786					
EP_NO: N/A					
Repair Type: No Action Needed					
Crossing Status: Found					
UCIP Comments:					
FIELD_STRUCT_DESC: 1 of 3: 36-inch corrugated metal drainage pipe through the levee, 7.3 feet below the crown. Flap gate and concrete U-shaped headwall on the waterside (WS) end. Concrete U-shaped headwall on the landside (LS) end. [Additional Reference(s): DWR Levee Log, 1992. USACE Sacramento O&M Manual 510, April 1963, (HLM 1.70) Drawing No. 50-4-3622].					
FS Date: 10/3/2013

Concrete inlet on LS toe.

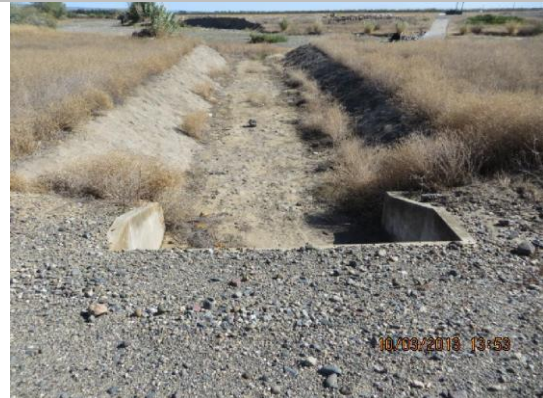
Photo 2 of 3 : UCIP_FA_2018_21769_37003.jpg

Concrete inlet on WS toe.

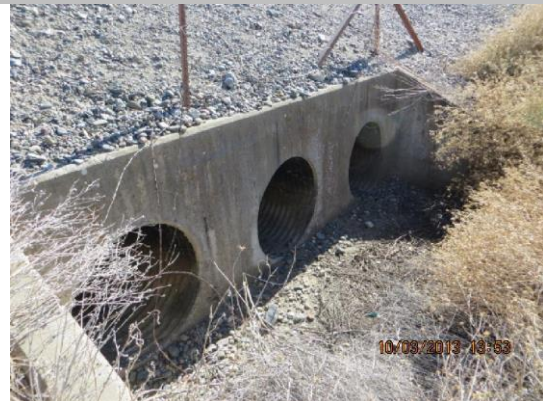
Photo 3 of 3 : UCIP_FA_2018_21769_37002.jpg

Concrete inlet on LS toe.

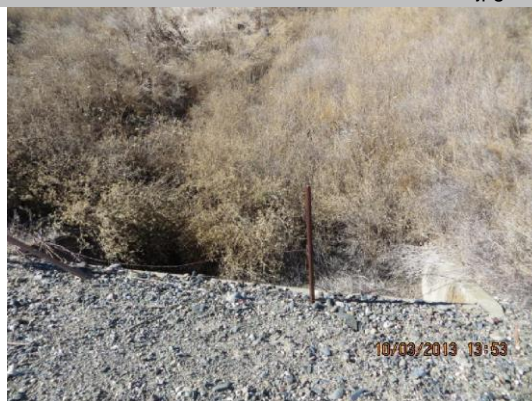
Photo 1 of 3 : UCIP_FA_2018_21768_37000.jpg

Concrete headwall on LS toe.

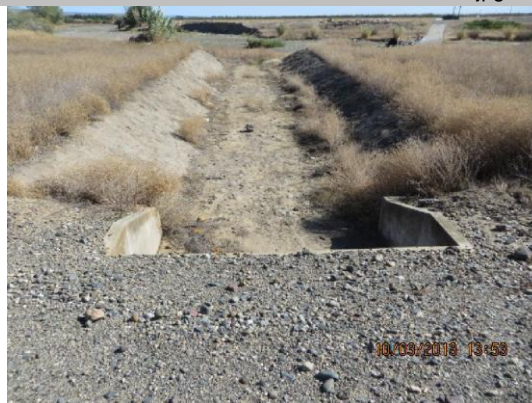
Photo 2 of 3 : UCIP_FA_2018_21768_36999.jpg

Concrete headwall on WS toe.

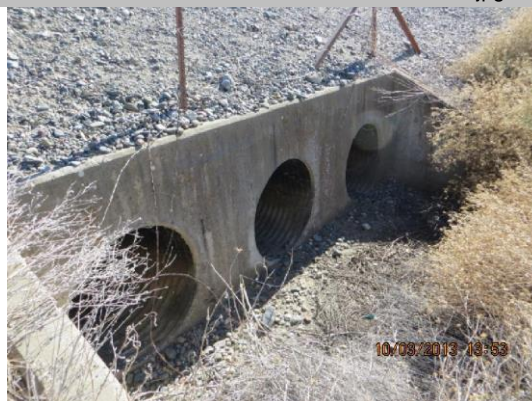
Photo 3 of 3 : UCIP_FA_2018_21768_36998.jpg

Concrete headwall on LS toe.

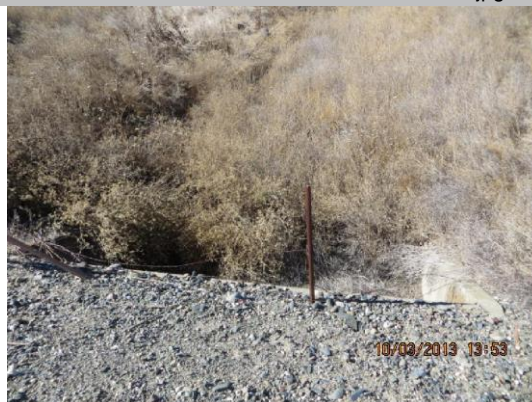
Photo 1 of 3 : UCIP_FA_2018_21767_36996.jpg

Concrete headwall on LS slope.

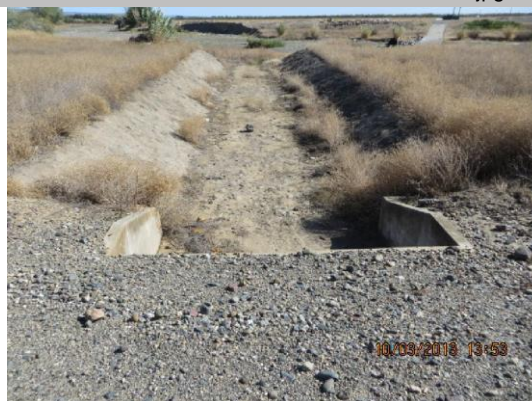
Photo 2 of 3 : UCIP_FA_2018_21767_36995.jpg

Concrete headwall on WS toe.

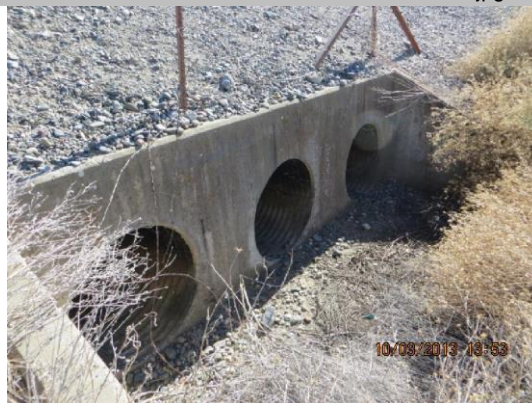
Photo 3 of 3 : UCIP_FA_2018_21767_36994.jpg

Concrete headwall on LS toe.

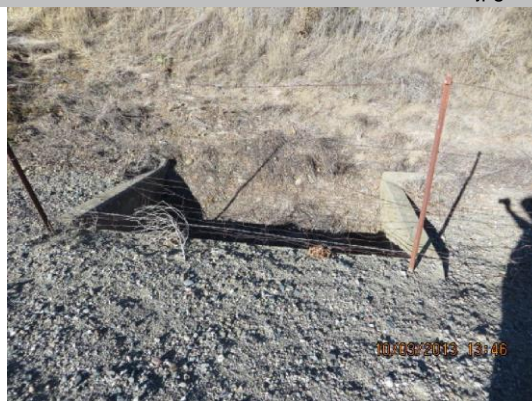
Photo 1 of 3 : UCIP_FA_2018_21766_36992.jpg

Concrete headwall on LS toe.

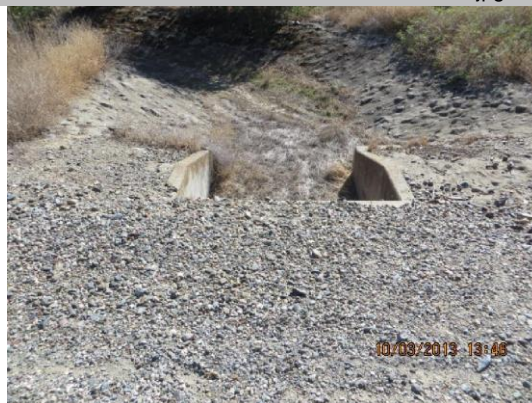
Photo 2 of 3 : UCIP_FA_2018_21766_36991.jpg

Concrete headwall on WS toe.

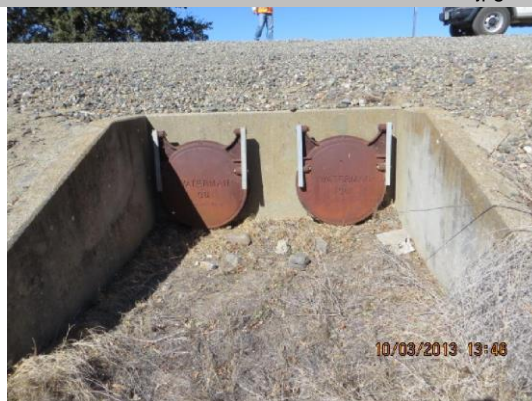
Photo 3 of 3 : UCIP_FA_2018_21766_36990.jpg

Flapgate on WS toe.

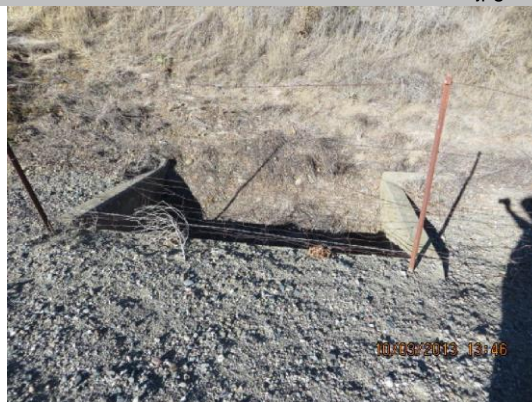
Photo 1 of 3 : UCIP_FA_2018_22828_38978.jpg

Concrete headwall on LS toe.

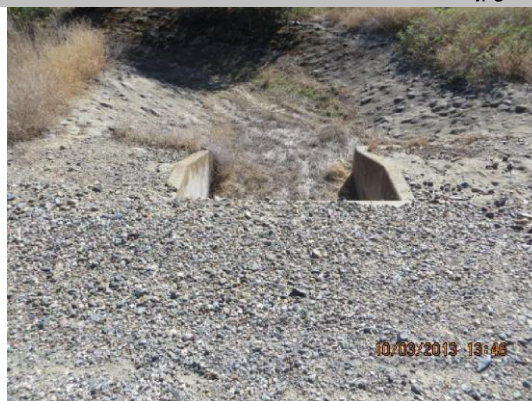
Photo 2 of 3 : UCIP_FA_2018_22828_38977.jpg

Concrete headwall and concrete channel on WS toe.

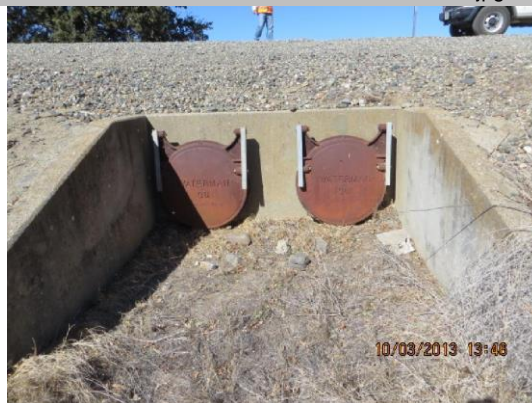
Photo 3 of 3 : UCIP_FA_2018_22828_38980.jpg

Flapgate on headwall at WS toe.

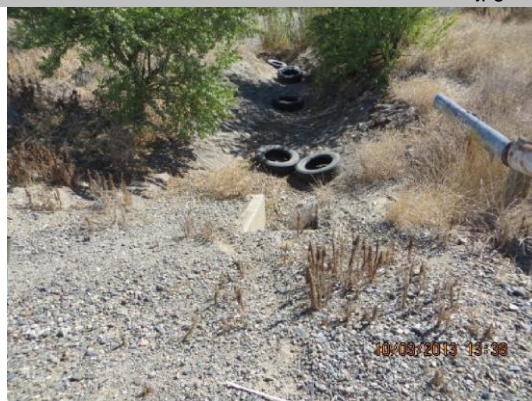
Photo 1 of 3 : UCIP_FA_2018_21763_36982.jpg

Concrete U-shaped headwall on WS slope.

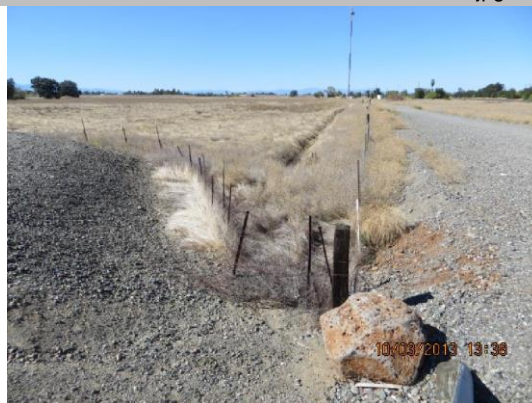
Photo 2 of 3 : UCIP_FA_2018_21763_36981.jpg

Inlet off LS toe in channel.

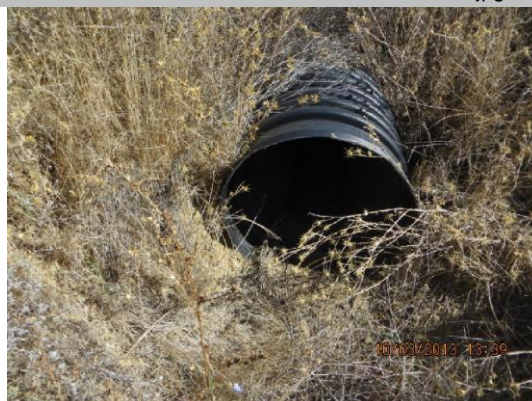
Photo 3 of 3 : UCIP_FA_2018_21763_36980.jpg

HDPE pipe inlet on LS toe.

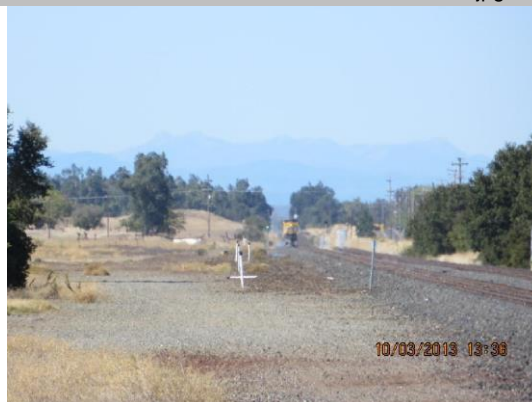
Photo 1 of 1 : UCIP_FA_2018_23051_39135.jpg

LM Start	2.23	Rating **	M	Issue No.	934
LM End	2.23	Issue Type +	En	Location *	
Category	Supplemental			GPS Latitude/Longitude	
				Start	End
Item	DWR UCIP Field Study			40.052063 °	40.052063 °
				-122.150450 °	-122.150450 °
DWR ID	24695				
Comment Code					
Inspector Comment					
FS_ID:23051 DS_ID:24695 EP_NO: N/A Repair Type: Non-Urgent Crossing Status: Found UCIP Comments: No permit identified for this crossing. FIELD_STRUCT_DESC: Fiber optics conduit of an unknown size or material through the levee, at an unknown depth. Signage on the landside (LS) visible. FS Date: 10/3/2013

Fiber optic line markers off LS shoulder.

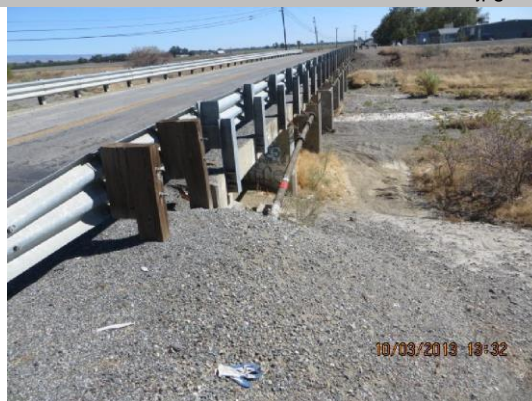
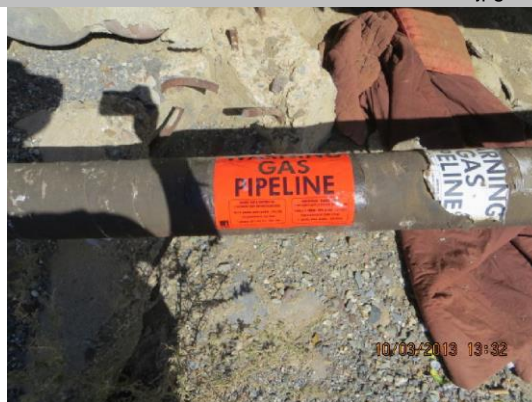
LM Start	2.28	Rating **	M	Issue No.	935	
LM End	2.28	Issue Type +	En	Location *		
Category	Supplemental			GPS Latitude/Longitude		
				Start	End	
Item	DWR UCIP Field Study			40.052379 °	40.052379 °	
				-122.149534 °	-122.149534 °	
DWR ID	24694					
Comment Code						
Inspector Comment						
FS_ID:23045 DS_ID:24694 EP_NO: N/A Repair Type: Non-Urgent Crossing Status: Found UCIP Comments: No permit identified for this crossing. FIELD_STRUCT_DESC: 4-inch coated steel gas pipeline through the levee, 3.5 feet below the crown. Pipe visible on upstream side of bridge. FS Date: 10/3/2013

Gasline on upstream side of bridge.

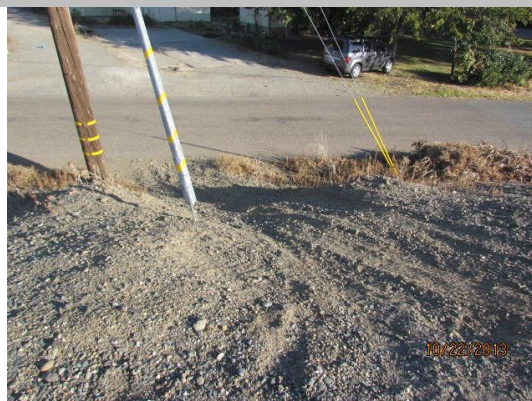
Photo 1 of 1 : FA_2018_NA0019_81_12_20180905_00007.jpg

View of the slope instability caused by vehicles along the landside slope.

LM Start	2.32	Rating **	M	Issue No.	12
LM End	2.32	Issue Type +	Ma	Location *	LS
Category	Earthen Levee			GPS Latitude/Longitude	
				Start	End
Item	Slope Stability			40.052443 °	40.052443 °
				-122.148863 °	-122.148863 °
DWR ID	DWR_NA0019_04_f_2013_12				
Comment Code					
S3 : Repair the levee slope damaged by vehicle traffic and prevent access where possible.					
Inspector Comment

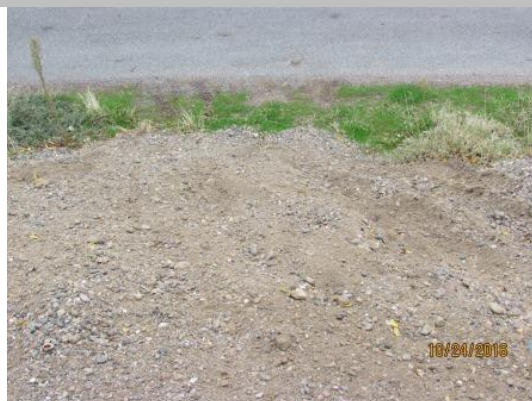
Photo 1 of 1 : FA_2018_NA0019_81_30_20180905_00017.jpg

View of the slope instability caused by vehicles along the landside slope.

LM Start	2.35	Rating **	M	Issue No.	30
LM End	2.35	Issue Type +	Ma	Location *	LS
Category	Earthen Levee			GPS Latitude/Longitude	
				Start	End
Item	Slope Stability			40.052450 °	40.052450 °
				-122.148352 °	-122.148352 °
DWR ID	DWR_NA0019_04_f_2016_30				
Comment Code					
S3 : Repair the levee slope damaged by vehicle traffic and prevent access where possible.					
Inspector Comment

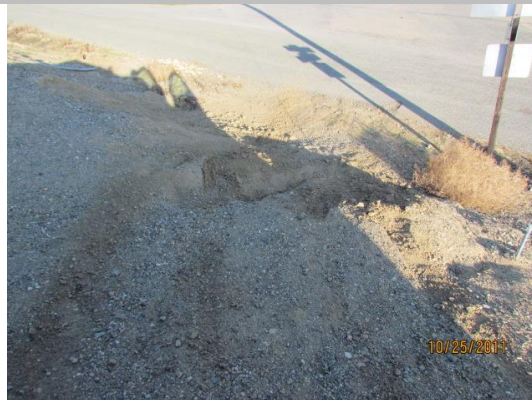
Photo 1 of 1 : FA_2018_NA0019_81_20_20180905_00012.jpg

View of the slope instability caused by vehicles along the landside slope.

LM Start	2.43	Rating **	M	Issue No.	20
LM End	2.43	Issue Type +	Ma	Location *	LS
Category	Earthen Levee			GPS Latitude/Longitude	
				Start	End
Item	Slope Stability			40.052417 °	40.052417 °
				-122.146747 °	-122.146747 °
DWR ID	DWR_NA0019_04_s_2012_20				
Comment Code					
S3 : Repair the levee slope damaged by vehicle traffic and prevent access where possible.					
Inspector Comment

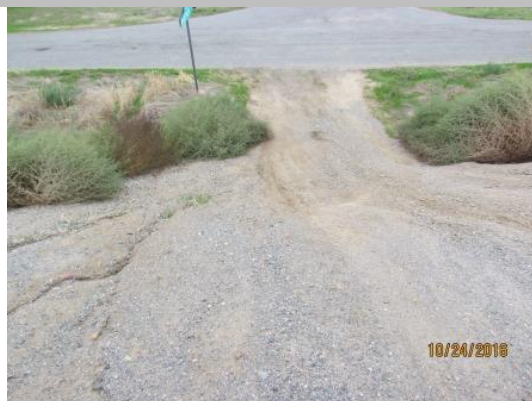
Photo 1 of 1 : FA_2018_NA0019_81_2_20180905_00002.jpg

View of the slope instability caused by vehicles along the landside slope.

LM Start	2.51	Rating **	M	Issue No.	2
LM End	2.51	Issue Type +	Ma	Location *	LS
Category	Earthen Levee			GPS Latitude/Longitude	
				Start	End
Item	Slope Stability			40.052872 °	40.052872 °
				-122.145495 °	-122.145495 °
DWR ID	DWR_NA0019_04_s_2012_2				
Comment Code					
S3 : Repair the levee slope damaged by vehicle traffic and prevent access where possible.					
Inspector Comment

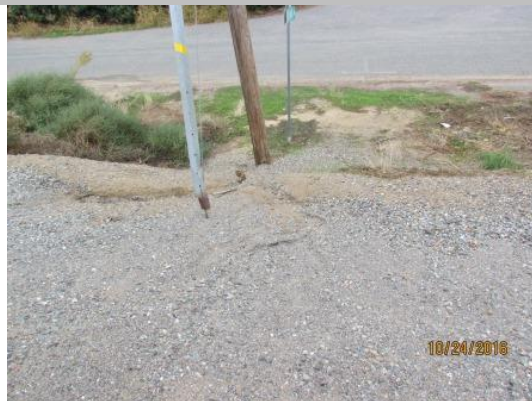
Photo 1 of 1 : FA_2018_NA0019_81_32_20180905_00019.jpg

View of the slope instability caused by vehicles along the landside slope.

LM Start	2.58	Rating **	M	Issue No.	32
LM End	2.58	Issue Type +	Ma	Location *	LS
Category	Earthen Levee			GPS Latitude/Longitude	
				Start	End
Item	Slope Stability			40.053767 °	40.053767 °
				-122.144719 °	-122.144719 °
DWR ID	DWR_NA0019_04_f_2016_32				
Comment Code					
S2 : Repair the levee slope damaged by foot traffic and prevent access where possible.					
Inspector Comment

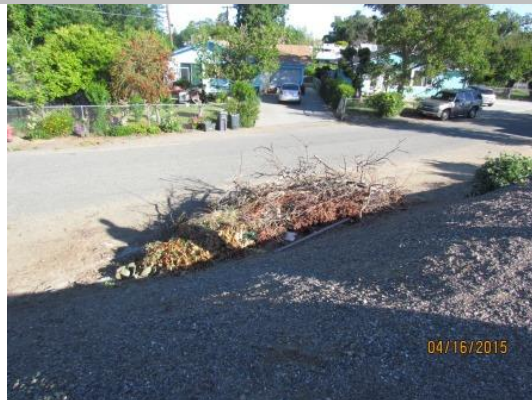
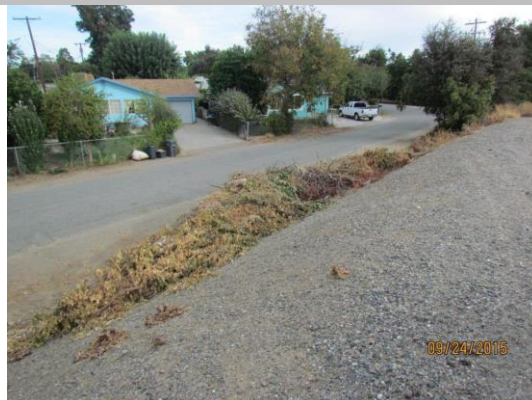
View of the prunings along the landside toe.

LM Start	2.63	Rating **	M	Issue No.	15
LM End	2.63	Issue Type +	En	Location *	LS
Category	Earthen Levee			GPS Latitude/Longitude	
				Start	End
Item	Encroachments			40.054337°	40.054337°
				-122.144235°	-122.144235°
DWR ID	DWR_NA0019_04_s_2015_15				
Comment Code					
PR : Prunings					
Inspector Comment					
Remove the prunings from the landside toe.

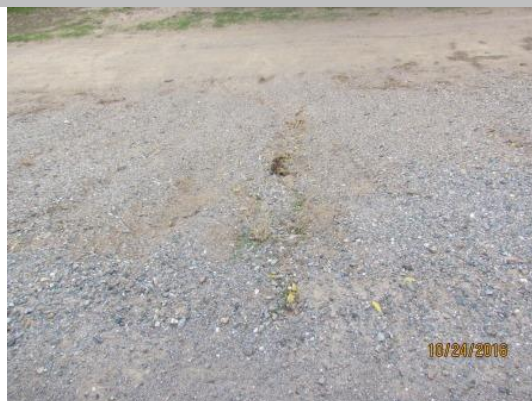
Photo 1 of 1 : FA_2018_NA0019_81_916_20180905_00024.jpg

LM Start	2.83	Rating **	M	Issue No.	916
LM End	2.86	Issue Type +	Ma	Location *	WS
Category	Earthen Levee			GPS Latitude/Longitude	
				Start	End
Item	Slope Stability			40.055596 °	40.055985 °
				-122.141322 °	-122.141385 °
DWR ID	DWR_NA0019_04_s_2012_916				
Comment Code					
S3 : Repair the levee slope damaged by vehicle traffic and prevent access where possible.					
Inspector Comment

View of the slope instability caused by vehicles along the waterside slope.

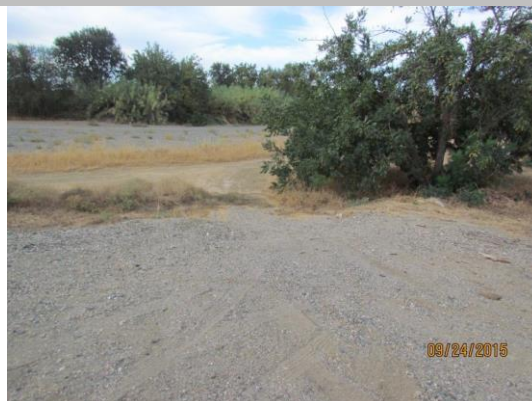
Photo 1 of 1 : FA_2018_NA0019_81_10_20180905_00006.jpg

LM Start	3.01	Rating **	M	Issue No.	10
LM End	3.01	Issue Type +	Ma	Location *	WS
Category	Earthen Levee			GPS Latitude/Longitude	
				Start	End
Item	Slope Stability			40.056388 °	40.056388 °
				-122.139168 °	-122.139168 °
DWR ID	DWR_NA0019_04_s_2012_10				
Comment Code					
S3 : Repair the levee slope damaged by vehicle traffic and prevent access where possible.					
Inspector Comment

View of the slope instability caused by vehicles along the landside slope.

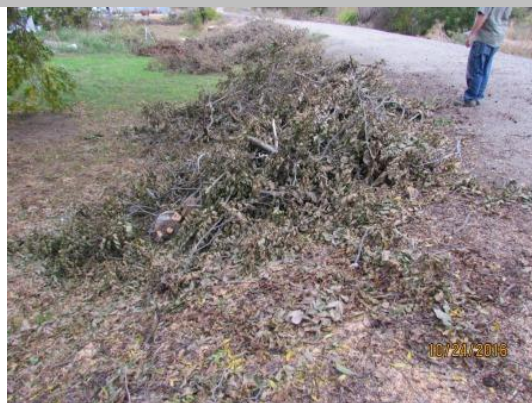
Photo 1 of 1 : FA_2018_NA0019_81_35_20180905_00020.jpg

LM Start	3.05	Rating **	M	Issue No.	35
LM End	3.10	Issue Type +	En	Location *	LS
Category	Earthen Levee		GPS Latitude/Longitude		
			Start	End	
Item	Encroachments		40.056405 °	40.056935 °	
			-122.138438 °	-122.138029 °	
DWR ID	DWR_NA0019_04_f_2016_35				
Comment Code					
PR : Prunings					
Inspector Comment					
Remove prunings from the landside toe.

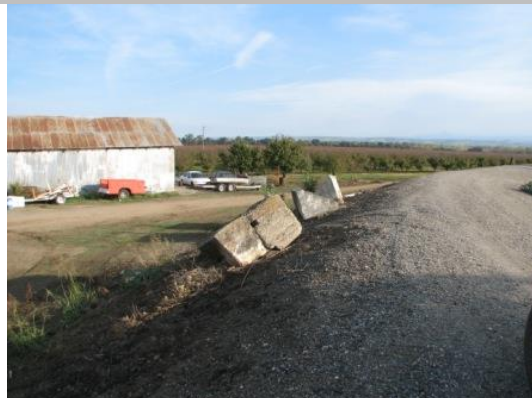
Photo 1 of 1 : FA_2018_NA0019_81_1_20180905_00001.jpg

LM Start	3.11	Rating **	M	Issue No.	1
LM End	3.13	Issue Type +	En	Location *	LS
Category	Earthen Levee			GPS Latitude/Longitude	
				Start	End
Item	Encroachments			40.057083 °	40.057291 °
				-122.137935 °	-122.137743 °
DWR ID	DWR_NA0019_04_s_2012_1				
Comment Code					
DE : Debris					
Inspector Comment					
Remove conctere blocks, concrete pipes, and concrete stairs from the landside slope.

View of the concrete stairways on the slope.

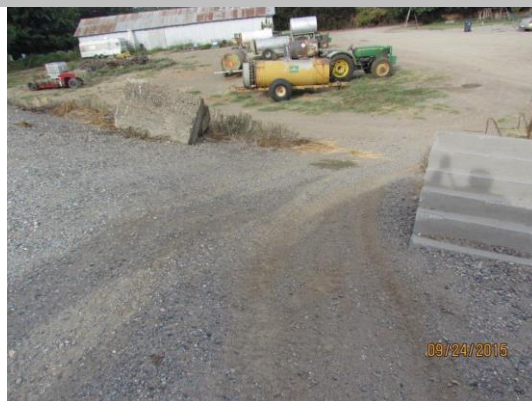
Photo 1 of 1 : FA_2018_NA0019_81_25_20180905_00014.jpg

LM Start	3.13	Rating **	M	Issue No.	25
LM End	3.13	Issue Type +	Ma	Location *	LS
Category	Earthen Levee			GPS Latitude/Longitude	
				Start	End
Item	Slope Stability			40.057350 °	40.057350 °
				-122.137667 °	-122.137667 °
DWR ID	DWR_NA0019_04_f_2015_25				
Comment Code					
S3 : Repair the levee slope damaged by vehicle traffic and prevent access where possible.					
Inspector Comment

View of the slope instability caused by vehicles along the landside slope.

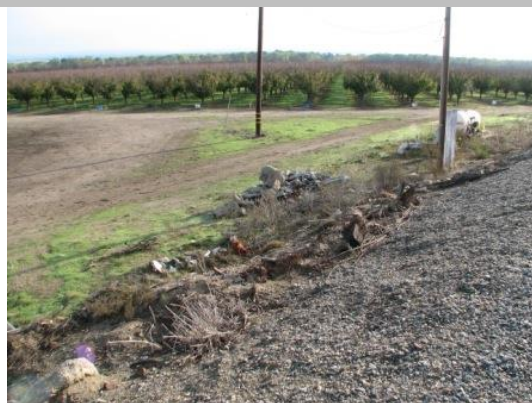
Photo 1 of 1 : FA_2018_NA0019_81_6_20180905_00005.jpg

LM Start	3.31	Rating **	M	Issue No.	6
LM End	3.31	Issue Type +	En	Location *	LS
Category	Earthen Levee			GPS Latitude/Longitude	
				Start	End
Item	Encroachments			40.057558 °	40.057558 °
				-122.134417 °	-122.134417 °
DWR ID	DWR_NA0019_04_s_2012_6				
Comment Code					
GA : Garbage					
Inspector Comment

View of the garbage and metal along the landside slope and toe of the levee.

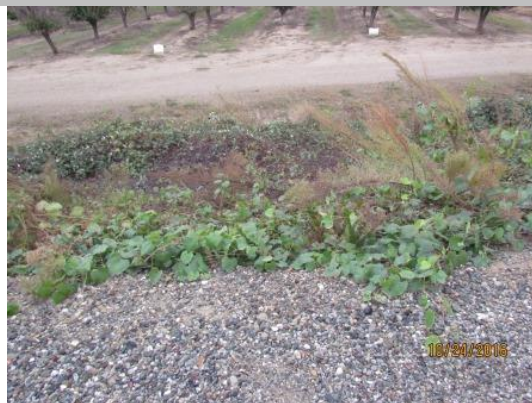
Photo 1 of 1 : FA_2018_NA0019_81_39_20180905_00021.jpg

LM Start	3.40	Rating **	M	Issue No.	39
LM End	3.44	Issue Type +	Ma	Location *	LS
Category	Earthen Levee			GPS Latitude/Longitude	
				Start	End
Item	Vegetation			40.056546 °	40.055906 °
				-122.133530 °	-122.133294 °
DWR ID	DWR_NA0019_04_f_2016_39				
Comment Code					
V2 : Remove the wild growth other than native grasses from the levee slopes.					
Inspector Comment

View of the blackberries along the landside slope blocking visibility and access.

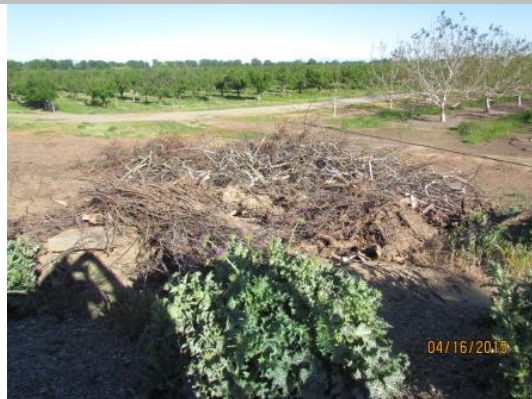
Photo 1 of 1 : FA_2018_NA0019_81_21_20180905_00013.jpg

LM Start	3.66	Rating **	M	Issue No.	21
LM End	3.66	Issue Type +	En	Location *	LS
Category	Earthen Levee			GPS Latitude/Longitude	
				Start	End
Item	Encroachments			40.055735 °	40.055735 °
				-122.129445 °	-122.129445 °
DWR ID	DWR_NA0019_04_s_2015_21				
Comment Code					
PR : Prunings					
Inspector Comment					
Remove the prunings from the landside toe.

View of the prunings along landside toe.

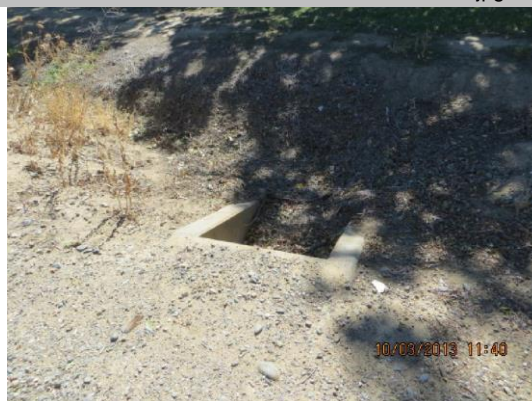
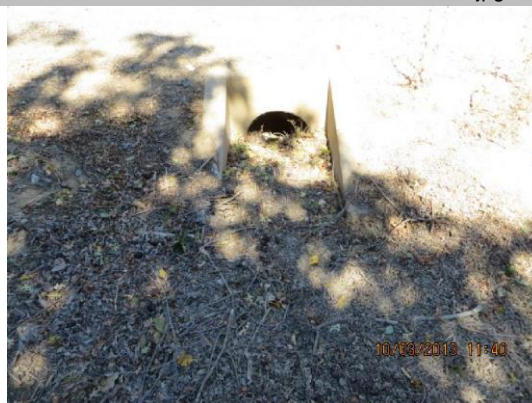
LM Start	0.11	Rating **	A/W	Issue No.	20
LM End	0.11	Issue Type +	Ma	Location *	
Category	Supplemental			GPS Latitude/Longitude	
				Start	End
Item	DWR UCIP LMA Responsibility			40.051702 °	40.051702 °
				-122.189922 °	-122.189922 °
DWR ID	20799				
Comment Code					
Inspector Comment					
FS_ID:21744 DS_ID:20799 EP_NO: N/A Repair Type: No Action Needed Crossing Status: Found UCIP Comments: FIELD_STRUCT_DESC: 24-inch corrugated metal drainage pipe through the levee, 5.4 feet below the crown. Flap gate on the waterside (WS) end. Concrete U-shaped headwalls on the WS and landside (LS) ends. [Additional Reference(s): DWR Levee Log, 1992. USACE Sacramento O&M Manual 510, April 1963, (HLM 0.11) Drawing No. 50-4-3622]. FS Date: 10/3/2013

Concrete headwall on LS toe.

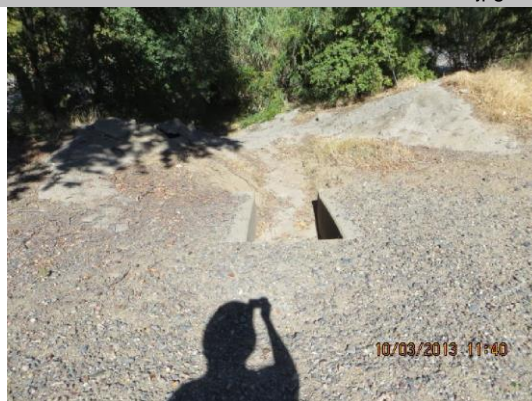
Photo 3 of 3 : UCIP_FA_2018_21744_36943.jpg

LM Start	0.11	Rating **	A/W	Issue No.	20 (cont)	
LM End	0.11	Issue Type +	Ma	Location *		
Category	Supplemental			GPS Latitude/Longitude		
				Start		End
Item	DWR UCIP LMA Responsibility			40.051702 °	40.051702 °	
				-122.189922 °	-122.189922 °	
DWR ID	20799					
Comment Code						
Inspector Comment						
FS_ID:21744 DS_ID:20799 EP_NO: N/A Repair Type: No Action Needed Crossing Status: Found UCIP Comments: FIELD_STRUCT_DESC: 24-inch corrugated metal drainage pipe through the levee, 5.4 feet below the crown. Flap gate on the waterside (WS) end. Concrete U-shaped headwalls on the WS and landside (LS) ends. [Additional Reference(s): DWR Levee Log, 1992. USACE Sacramento O&M Manual 510, April 1963, (HLM 0.11) Drawing No. 50-4-3622]. FS Date: 10/3/2013

Concrete U-shaped headwall on WS slope.

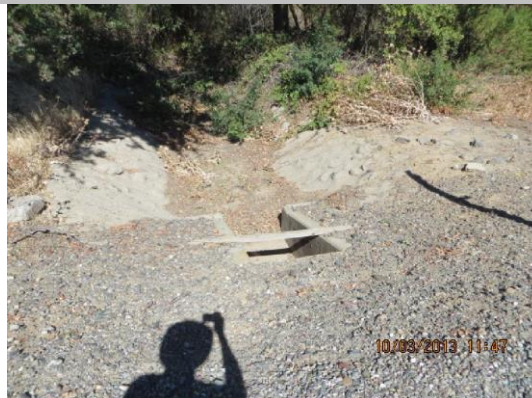
Photo 1 of 3 : UCIP_FA_2018_41124_36953.jpg

LM Start	0.50	Rating **	M	Issue No.	21	
LM End	0.50	Issue Type +	Ma	Location *		
Category	Supplemental			GPS Latitude/Longitude		
				Start	End	
Item	DWR UCIP LMA Responsibility			40.050585 °	40.050585 °	
				-122.182972 °	-122.182972 °	
DWR ID	20801					
Comment Code						
Inspector Comment						
FS_ID:41124 DS_ID:20801 EP_NO: N/A Repair Type: Non-Urgent Crossing Status: Found UCIP Comments: Debris inside pipe at WS toe needs to be removed as it may prevent proper operation of the flapgate. FIELD_STRUCT_DESC: 24-inch corrugated metal drainage pipe through the levee, 5.2 feet below the crown. Flap gate on the waterside (WS) end. Concrete U-shaped headwalls on the WS and landside (LS) ends. [Additional Reference(s): DWR Levee Log, 1992. USACE Sacramento O&M Manual 510, April 1963, (HLM 0.51) Drawing No. 50-4-3622]. FS Date: 10/3/2013

Concrete headwall on WS toe.

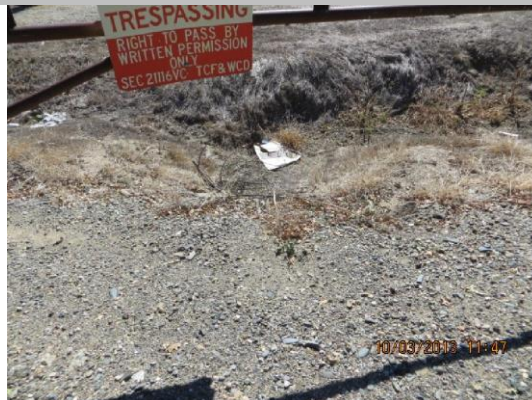
Photo 2 of 3 : UCIP_FA_2018_41124_36952.jpg

Inlet at LS toe.

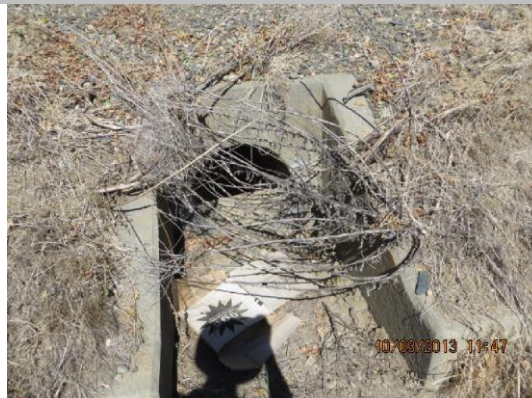
Photo 3 of 3 : UCIP_FA_2018_41124_36951.jpg

LM Start	0.50	Rating **	M	Issue No.	21 (cont)	
LM End	0.50	Issue Type +	Ma	Location *		
Category	Supplemental			GPS Latitude/Longitude		
				Start		End
Item	DWR UCIP LMA Responsibility			40.050585 °		40.050585 °
				-122.182972 °		-122.182972 °
DWR ID	20801					
Comment Code						
Inspector Comment						
FS_ID:41124 DS_ID:20801 EP_NO: N/A Repair Type: Non-Urgent Crossing Status: Found UCIP Comments: Debris inside pipe at WS toe needs to be removed as it may prevent proper operation of the flapgate. FIELD_STRUCT_DESC: 24-inch corrugated metal drainage pipe through the levee, 5.2 feet below the crown. Flap gate on the waterside (WS) end. Concrete U-shaped headwalls on the WS and landside (LS) ends. [Additional Reference(s): DWR Levee Log, 1992. USACE Sacramento O&M Manual 510, April 1963, (HLM 0.51) Drawing No. 50-4-3622]. FS Date: 10/3/2013

Concrete headwall at LS toe.

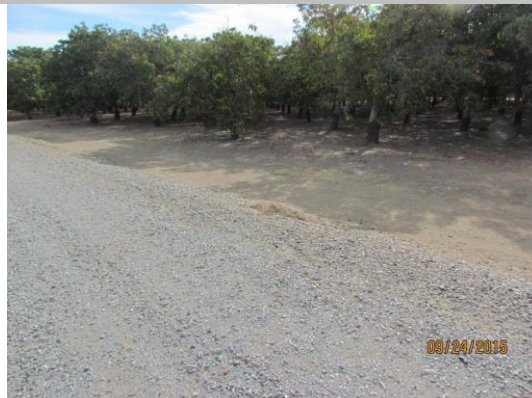
Photo 1 of 1 : FA_2018_NA0019_82_8_20180905_00003.jpg

LM Start	0.94	Rating **	M	Issue No.	8
LM End	1.05	Issue Type +	Ma	Location *	LS
Category	Earthen Levee			GPS Latitude/Longitude	
				Start	End
Item	Animal Control			40.051360 °	40.052361 °
				-122.175063 °	-122.173450 °
DWR ID	DWR_NA0019_05_f_2015_8				
Comment Code					
A1 : Exterminate rodents and backfill and compact or grout burrows.					
Inspector Comment					
Repair rodent hole on landside slope.

View of the rodent holes along the landside slope.

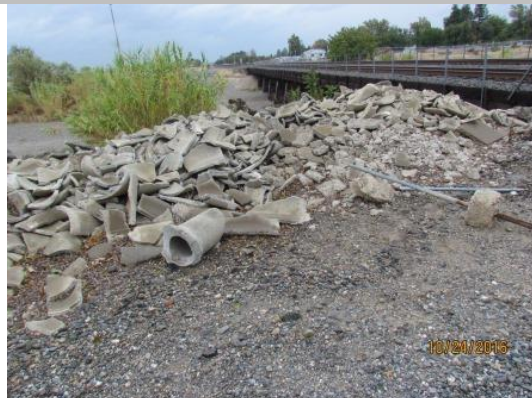
Photo 1 of 1 : FA_2018_NA0019_82_14_20180905_00005.jpg

LM Start	2.41	Rating **	M	Issue No.	14
LM End	2.41	Issue Type +	En	Location *	LS
Category	Earthen Levee			GPS Latitude/Longitude	
				Start	End
Item	Encroachments			40.051274 °	40.051274 °
				-122.150113 °	-122.150113 °
DWR ID	DWR_NA0019_05_f_2016_14				
Comment Code					
DE : Debris					
Inspector Comment					
Pile of broken concrete pipes on the waterside.

View of the broken pipes along the waterside slope.

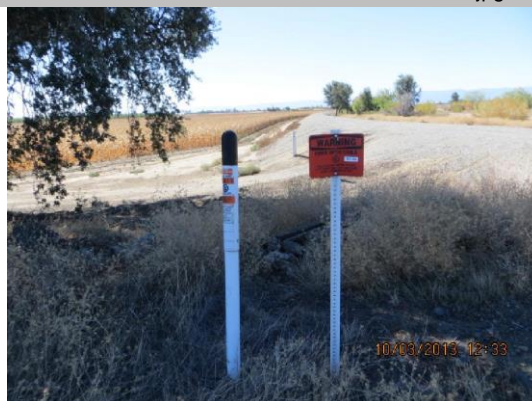
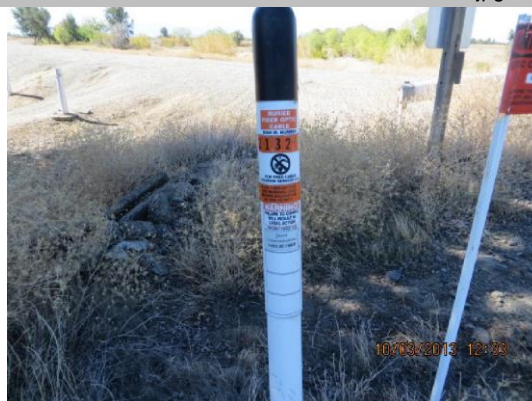
LM Start	2.41	Rating **	M	Issue No.	22
LM End	2.41	Issue Type +	En	Location *	
Category	Supplemental			GPS Latitude/Longitude	
				Start	End
Item	DWR UCIP Field Study			40.051336 °	40.051336 °
				-122.149991 °	-122.149991 °
DWR ID	24692				
Comment Code					
Inspector Comment					
FS_ID:23052					
DS_ID:24692					
EP_NO: N/A					
Repair Type: Non-Urgent					
Crossing Status: Found					
UCIP Comments: No permit identified for this crossing.					
FIELD_STRUCT_DESC: Steel fiber optics conduit of an unknown size through the levee, at an unknown depth. Sign markers on the landside (LS) shoulder.					
FS Date: 10/3/2013 9:02:00 AM

Fiber optic line markers on LS shoulder.

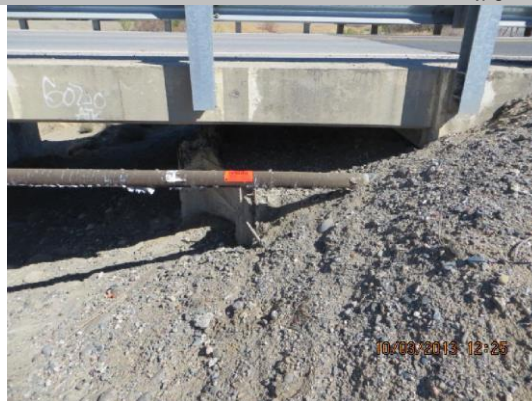
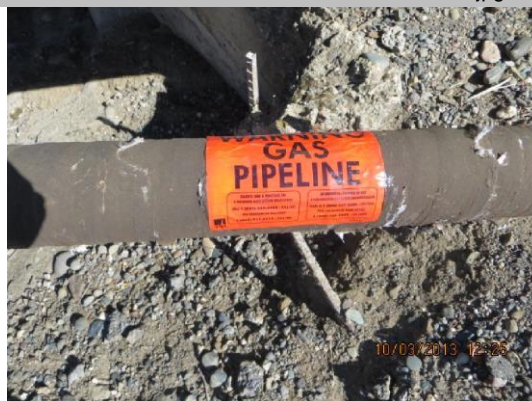
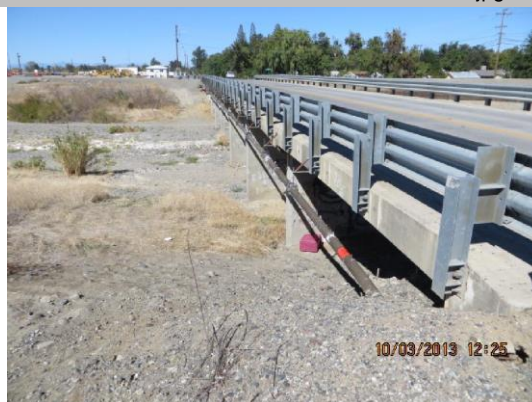
LM Start	2.47	Rating **	M	Issue No.	23
LM End	2.47	Issue Type +	En	Location *	
Category	Supplemental			GPS Latitude/Longitude	
				Start	End
Item	DWR UCIP Field Study			40.051667 °	40.051667 °
				-122.149033 °	-122.149033 °
DWR ID	24693				
Comment Code					
Inspector Comment					
FS_ID:23044 DS_ID:24693 EP_NO: N/A Repair Type: Non-Urgent Crossing Status: Found UCIP Comments: No permit identified for this crossing. FIELD_STRUCT_DESC: 4-inch steel gas pipeline through the levee, 2.5 feet below the crown. Pipe visible on upstream side of bridge. FS Date: 10/3/2013

Gasline on upstream side of bridge.

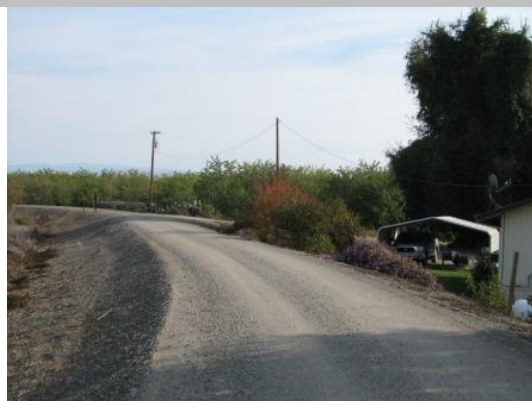
Photo 1 of 1 : FA_2018_NA0019_82_2_20180905_00001.jpg

LM Start	2.65	Rating **	M	Issue No.	2
LM End	2.70	Issue Type +	En	Location *	LS
Category	Earthen Levee			GPS Latitude/Longitude	
				Start	End
Item	Vegetation			40.051778 °	40.052243 °
				-122.145745 °	-122.144825 °
DWR ID	DWR_NA0019_05_s_2012_2				
Comment Code					
V6 : Landscaping					
Inspector Comment

View of the landscaping along the slope.

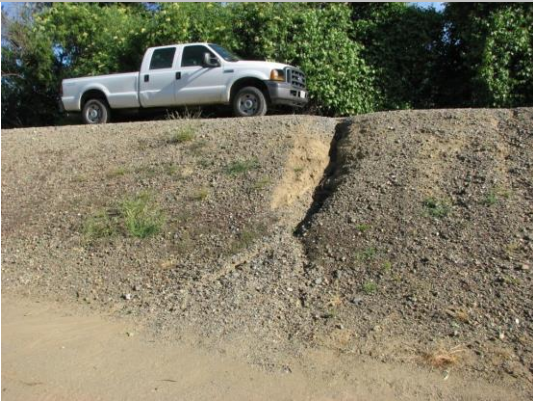
Photo 1 of 1 : FA_2018_NA0019_82_10_20180905_00004.jpg

View of the erosion along the landside slope.

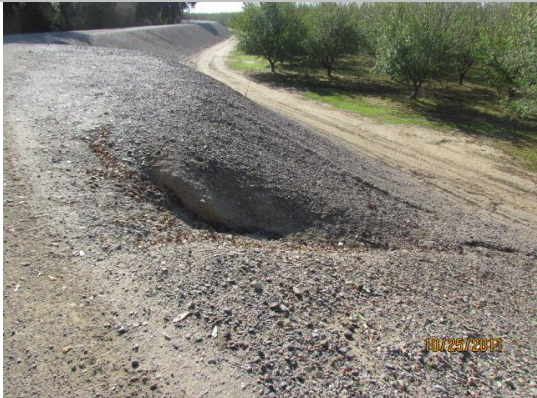
Photo 1 of 1 : FA_2018_NA0019_82_7_20180905_00002.jpg

View of the erosion along the landside slope.
